TRANSLOADER INTERNATIONAL CSM Site Summary

TRANSLOADER INTERNATIONAL

Oregon DEQ ECSI #: 2367

8888 NW St. Helens Rd. (ECSI incorrectly lists the address as 8444 NW St. Helens Rd.)

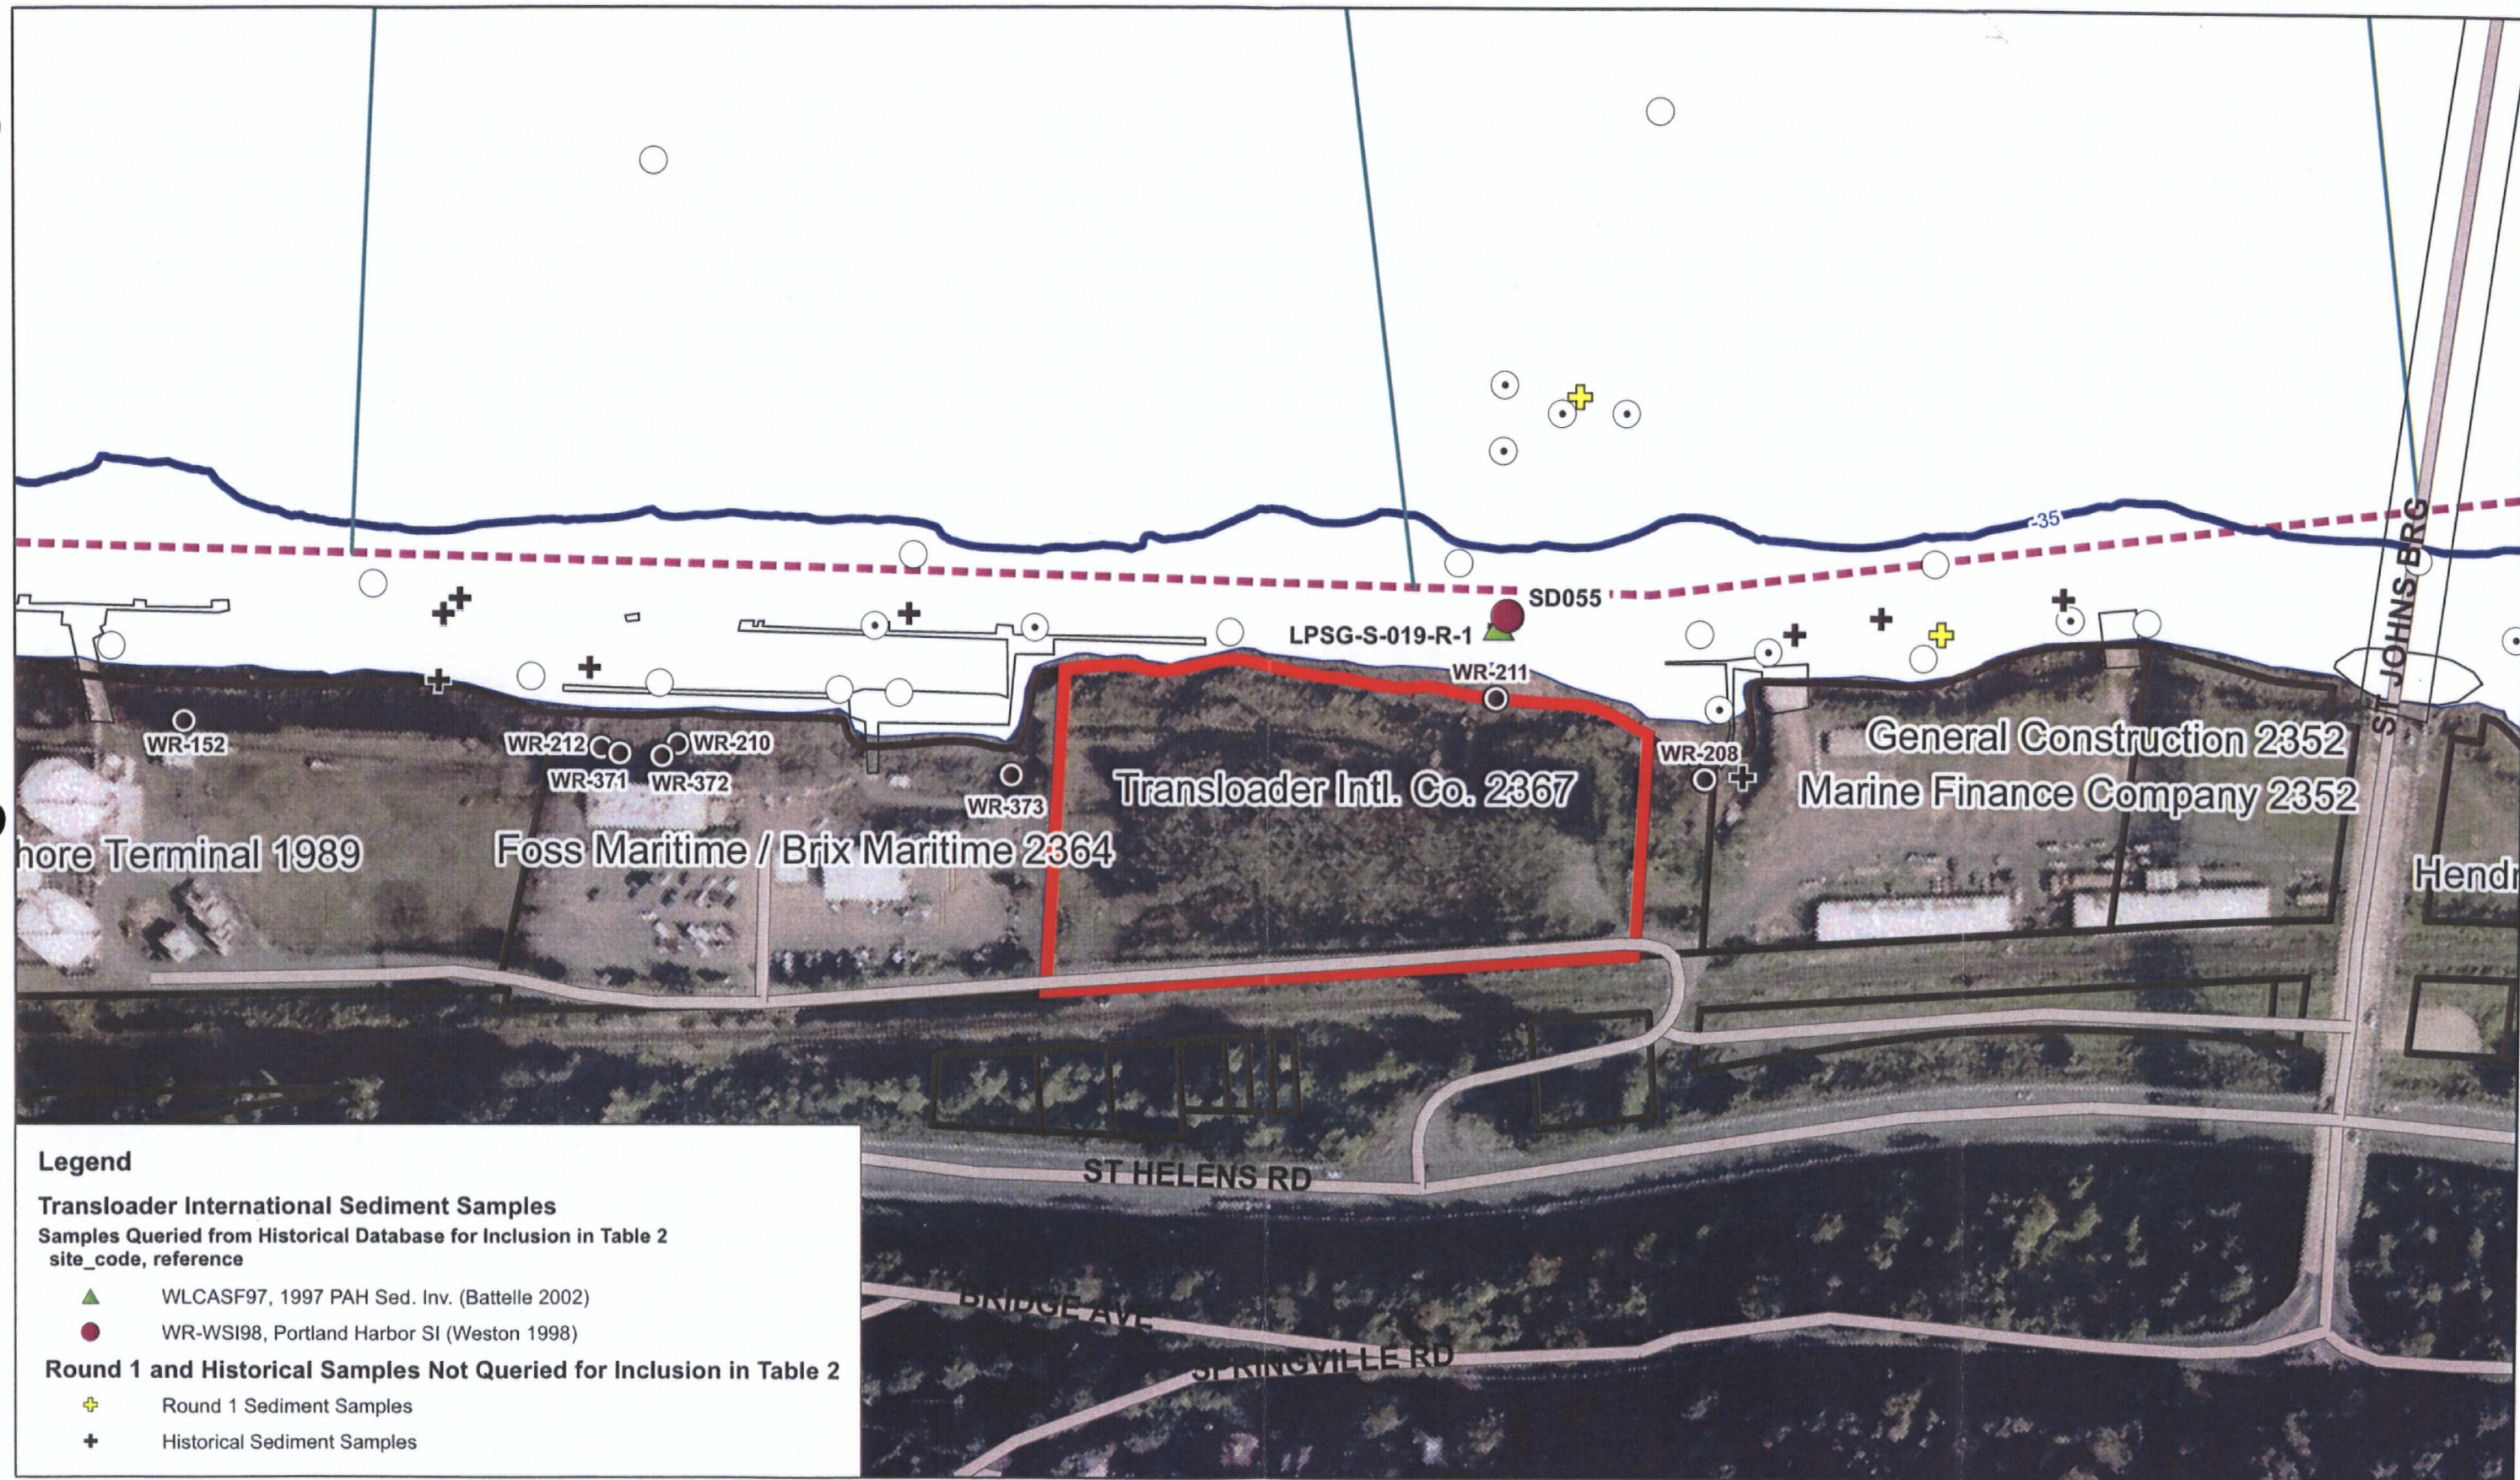
Figure 1-Site Features
 Portland Harbor RI/FS
 Conceptual Site Model
 Transloader International
 ECSI 2367

There is a private stormwater outfall (WR-211) located in the southern portion of the property (Figure 1), but potential sources to the river through this outfall are unknown.

The Transloader International site lies at approximately RM 5.6 on approximately 5 acres in an area zoned for mixed industrial, commercial, and residential use (Figure 1). To the north of the property is Foss Maritime/Brix Marine (ECSI #2364), St. Helens road lies to the west, and Marine Finance Corporation (#2352) abuts the property to the south. Integral noted in January 2005 that site had been recently cleared, but no noticeable structures are present (Sund 2005, pers. comm.).

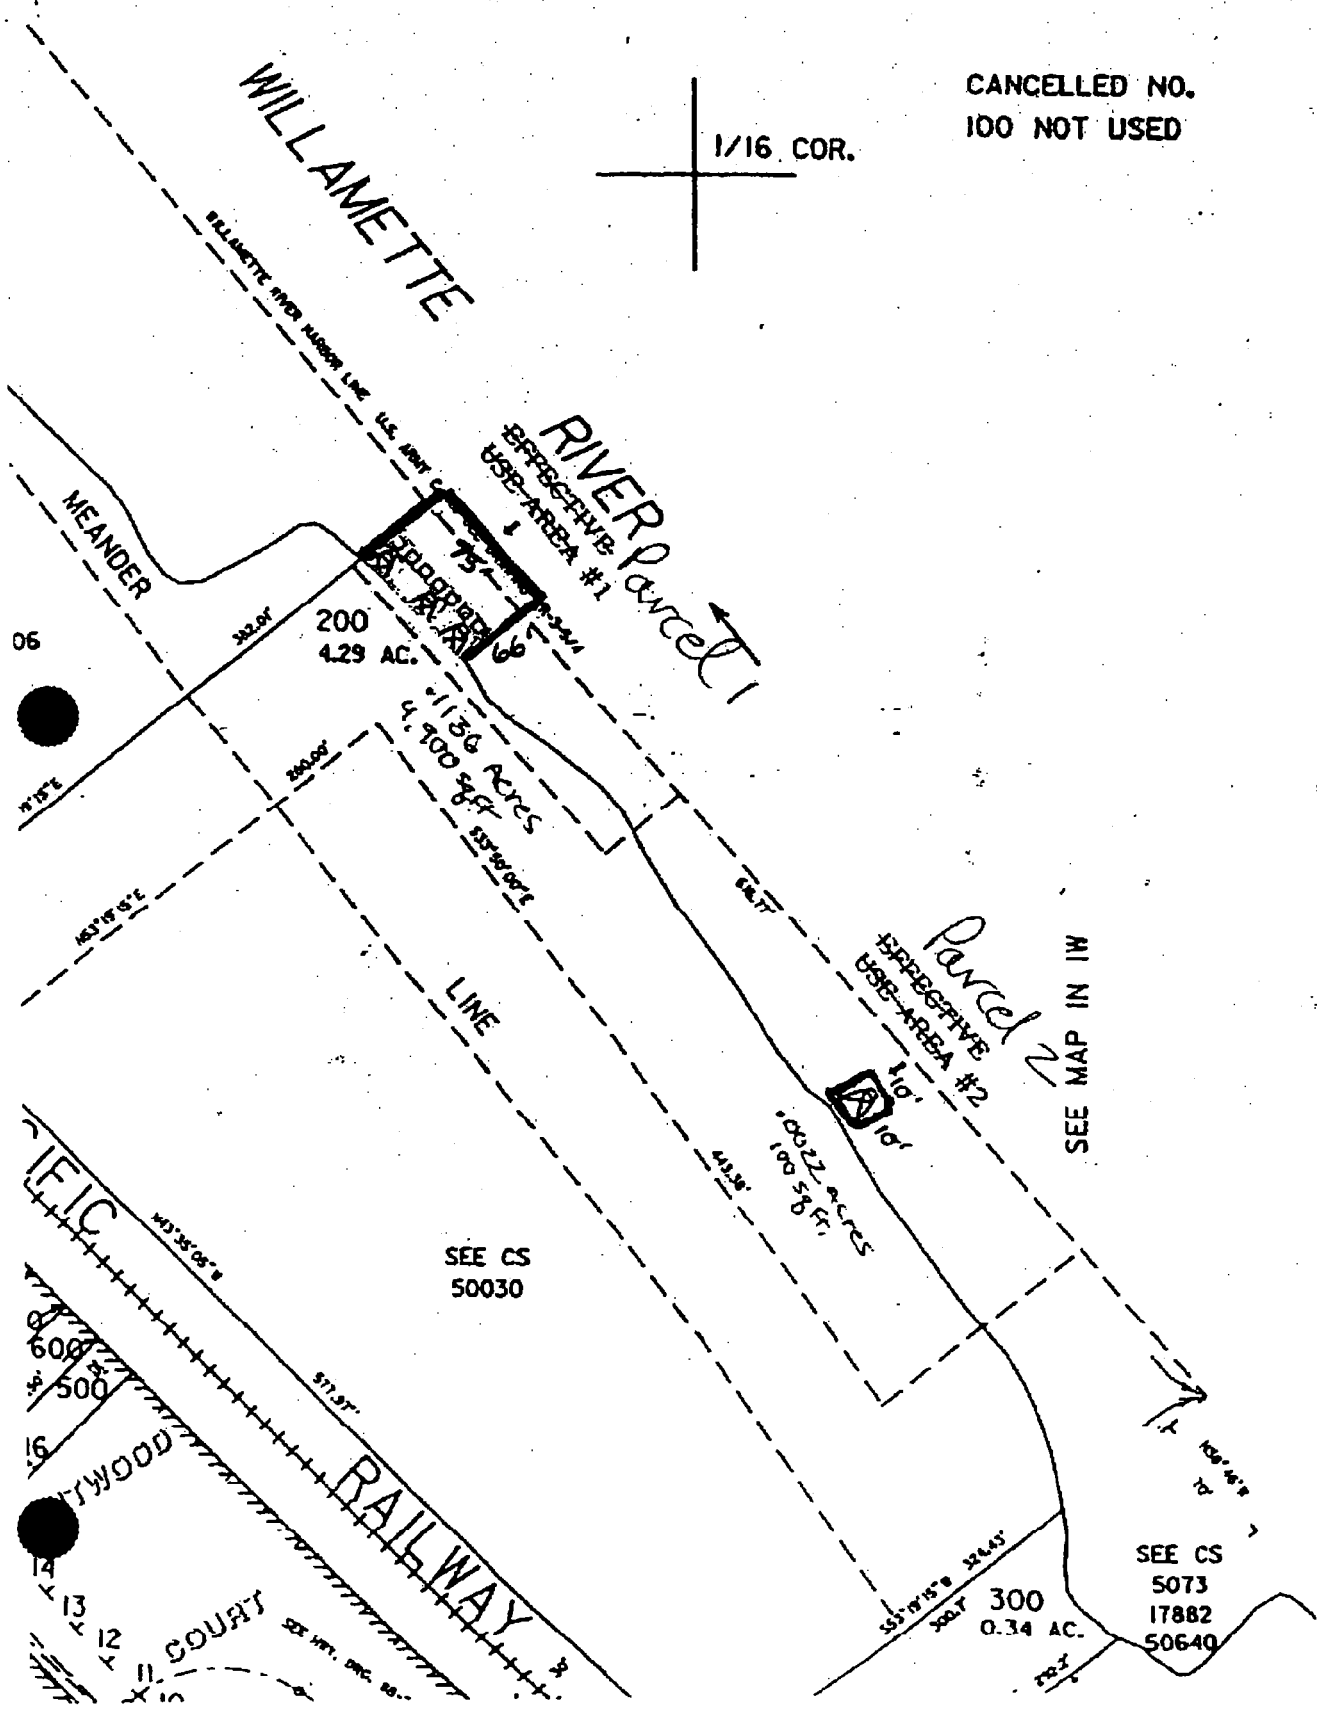
Exhibit A. Waterway Lease Map

Transloader International applied for a lease of two over-water parcels from the Oregon DSL in January 2000 (see Supplemental Figure, Exhibit A). Parcel 1 is approximately 0.1136 acres (4,900 square feet), containing three dolphins and a 3-ft-wide floating walkway. Parcel 2 is 0.0022 acres (100 square feet), encompassing a single dolphin. As of January 2005, these structures have not been built (Sund 2005, pers. comm.).

KEY: inch = 100 feet)
 30' steel dolphins (6' across at base)
 3' wide floating walkway

(see Supplemental Figure, Exhibit A). Parcel 1 is approximately 0.1136 acres (4,900 square feet); Parcel 2 is 0.0022 acres (100 square feet). Both parcels were leased to support "workboat moorage," but, as of January 2000, these moorage structures have not been built (Sund 2005, pers. comm.).
